## Detailed design for the slope face in association with the road disaster prevention work

The face and toe of slope of the prefectural road were deformed due to the passages of a front in August and No. 22 and 23 typhoons in October, 2004. This disaster was likely to be caused by heavy rain, but its mechanism was unsolved. In this project, we worked on identifying the causes to consider the construction method appropriate as countermeasure. Our analysis on hydrologic groundwater revealed that the groundwater level under the slope face rises before and after the road construction, and that the rise in the groundwater level weakens the stability of the slope. Based on these result, we proposed and implemented the construction of a relief well as permanent measure.

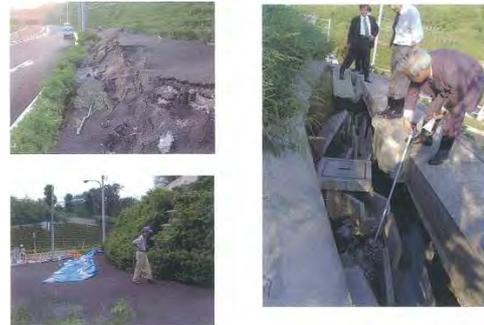
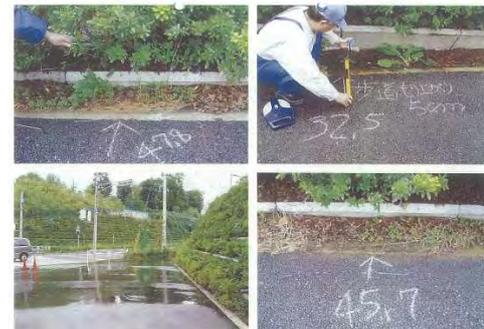
Deformed face of slope
